METAL PLUS LLC

TEST REPORT

ANSI/ASSE Z359.18 (SECTIONS 4.2.1.1, 4.2.2.1 AND 4.2.3.1) TESTING
OF UNIVERSAL SAFETY ANCHOR

J5196.01-109-42

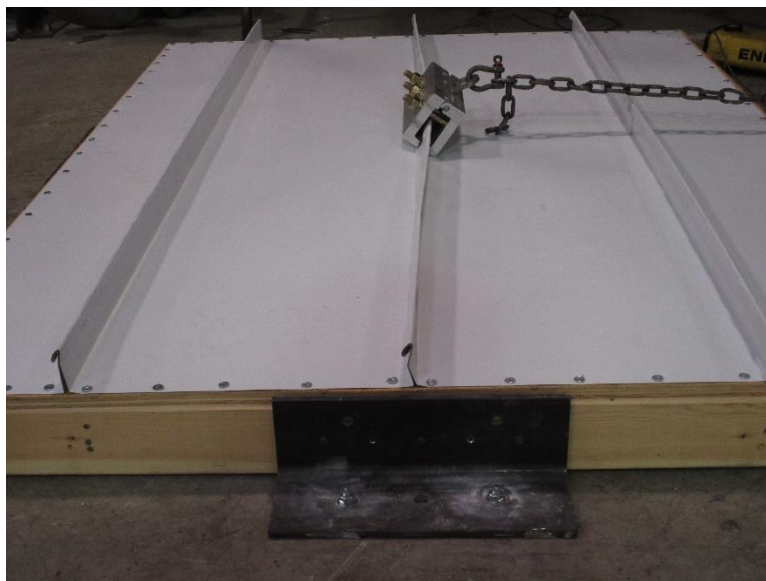
Photo No. 3

Specimen under Load during Test Perpendicular to Direction of Standing Seam Roof

TEST	MAXIMUM LOAD (lb)	SIMULATED SUBSTRATE	BOLT INSTALLATION TORQUE (ft-lbs)	OBSERVATIONS
Static Strength	4675	24 gauge	60	The specimen did not achieve specified load due to deformation/cracking of mechanical standing seam. Anchor undamaged.
Dynamic Strength	5083	24 gauge	60	The seam of the simulated substrate panels opened up to create a 12" wide by 1/2" (at largest) gap.
Residual Strength	4526	24 gauge	60	The seam of the simulated substrate panels opened up to create a 16" wide by 1" (at largest) gap. There was no additional movement during the 60 second hold time.
